**An ASABE Meeting Presentation**

**Paper Number: 084034**

## **Dry Creek – The Removal of a Barrier to Fish Passage and Restoration of a Stream in Napa County, California**

**Carolyn M. Jones, Agricultural PE, Civil PE**

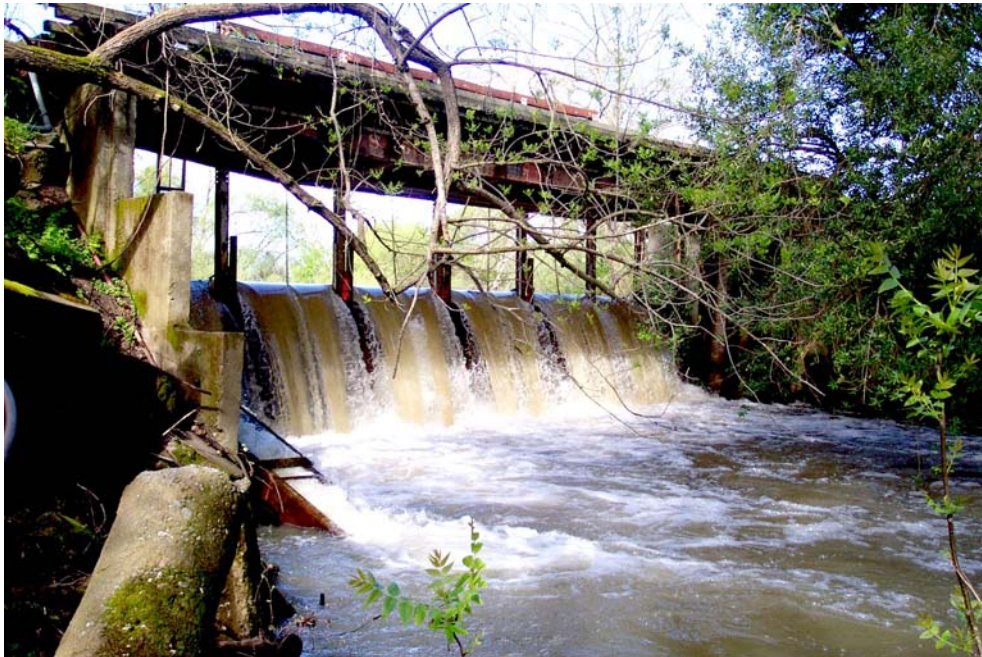
Figure 3. Looking upstream at the Dry Creek Dam while the flashgates are down and holding back water. Note water flowing through the fish ladder on the lower left.

Previously when barriers have been identified, measures were taken to help fish get past them which usually involved installation of fish ladders. Unfortunately, the fish ladders in this system only flowed when the reservoir was full and, hence, did not serve a portion of the fish population. When the ladder was flowing, fish had to navigate to it and then work their way up the frothing structure which must have been difficult.

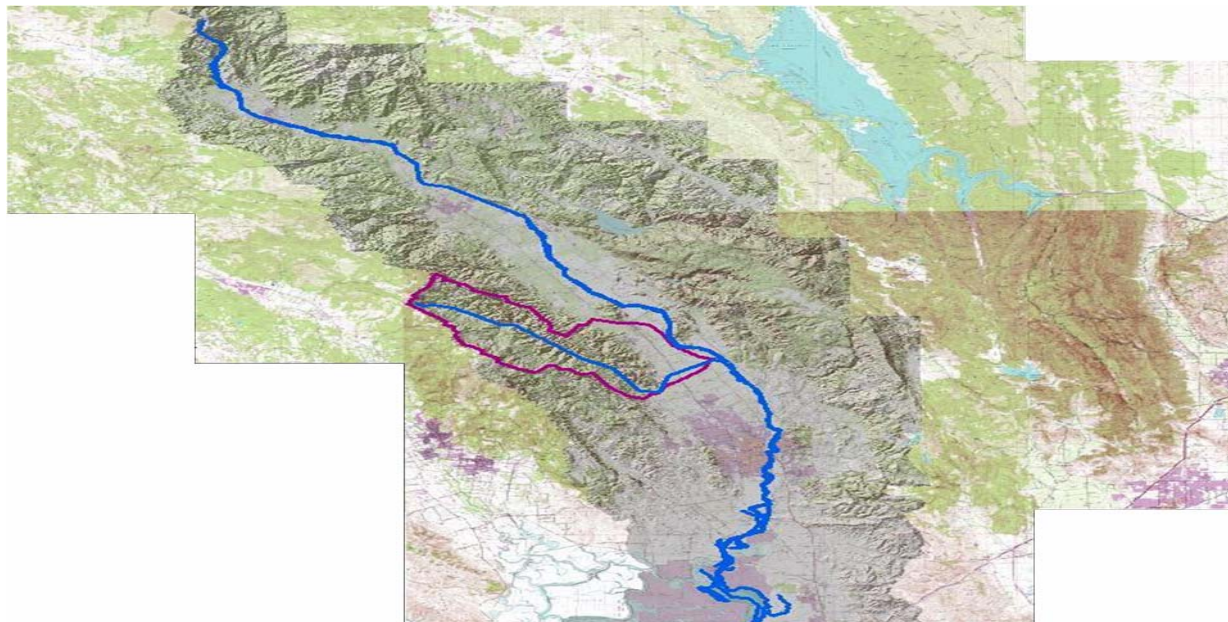
Figure 4. An orthogonal view of the Napa River Watershed. The watershed feeding the Dry Creek Reservoir is outlined in purple. The blue line within it is Dry Creek. The blue line continuing up the valley is the Napa River and drains to the San Pablo Bay at the bottom of the picture. Note that Dry Creek lies very low in the Napa River watershed.

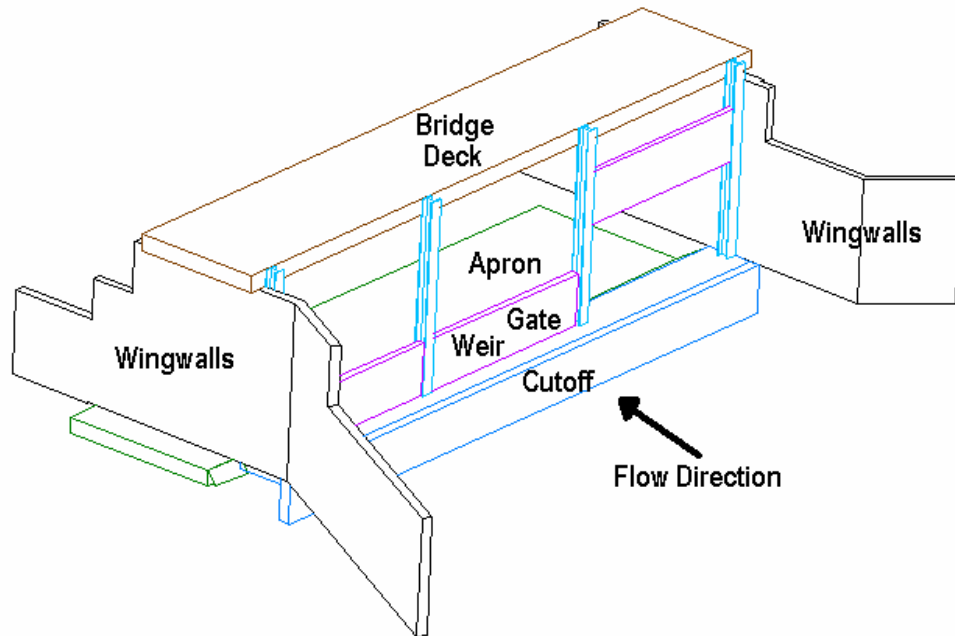
Figure 5. Wireframe depiction of the dam structure on Dry Creek (without the fish ladder).

Water from the 17,000 acre (27.8 square miles) watershed was retained behind the dam at the confluence of Dry and Hopper Creeks periodically between January and April. During below-freezing nights, water pumped from the reservoir into sprinkler systems prevented frost damage on the neighboring winegrape vineyards.

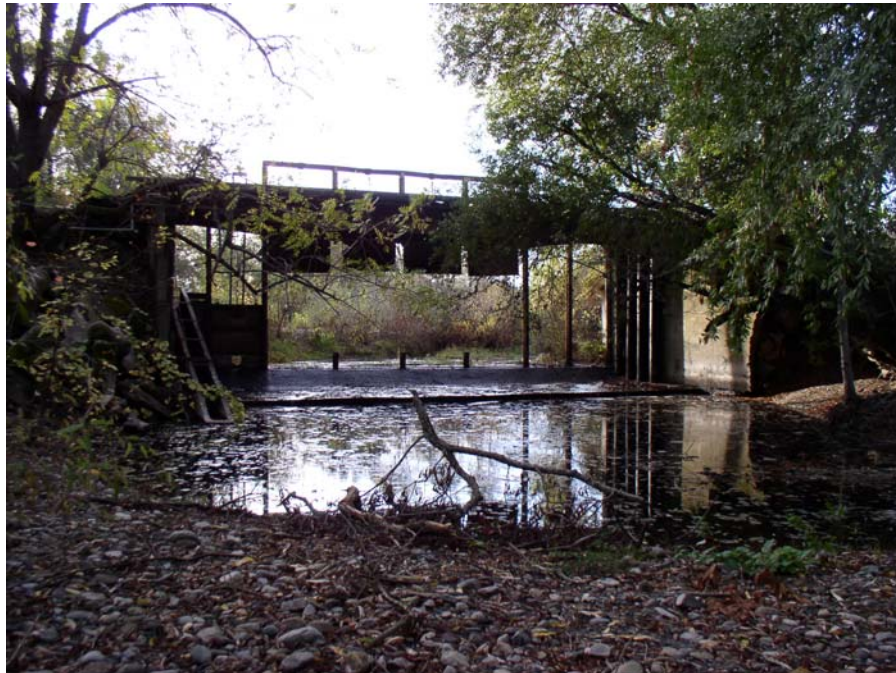
Figure 6. Looking upstream at the dam structure on Dry Creek originally constructed in the 1960s. Note that the I-beams that supported the flashgates have been cut in this picture.

Flashgates – the steel plates that are supported by I-beams. The I-beams sat vertically between the railcar bridge and the concrete apron. When the flashgates were down, the dam held water for frost protection.

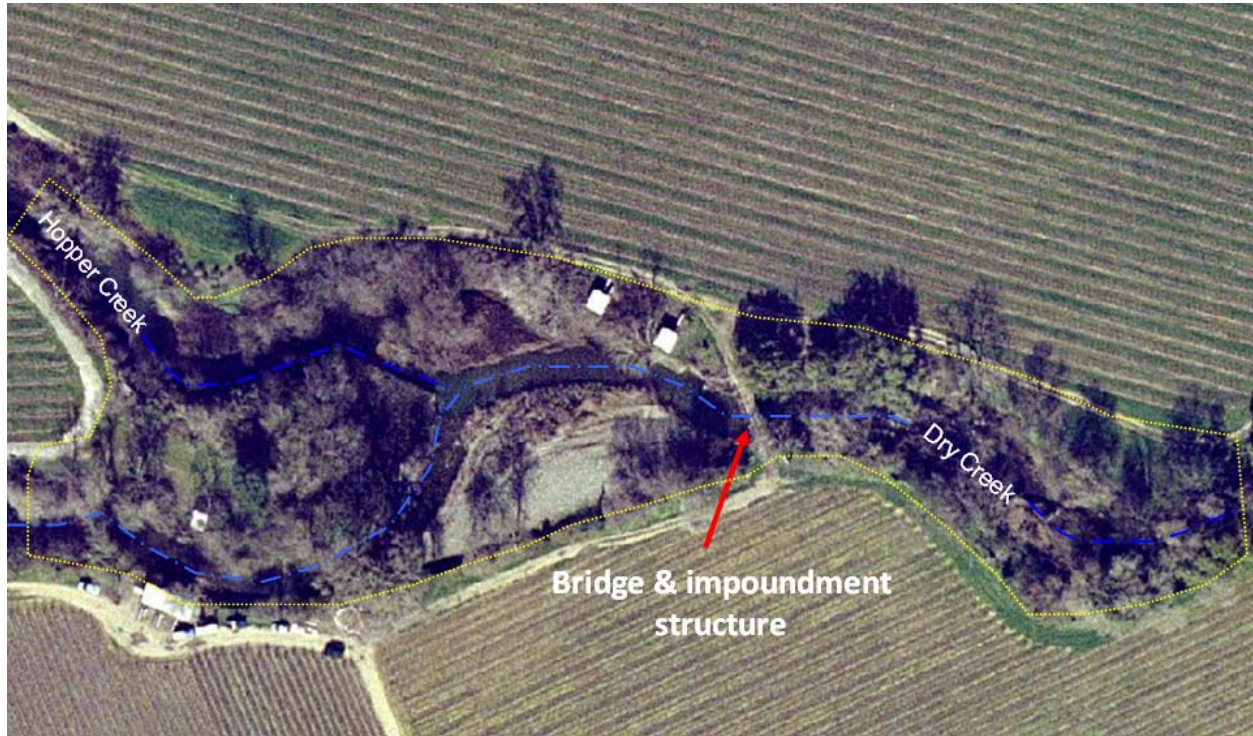
Figure 7. Aerial view of the site prior to dam removal.

Downstream of the apron, a plunge pool developed annually during large storms in conjunction with a downstream gravel bar as sediments were transported past the structure. Upstream of the structure a gravel bar developed and continued to increase slowly over the life of the structure. At the confluence, the bar acts as a floodplain when flows exceed the 2-5 year storm interval and will probably always exist as part of the functioning system.

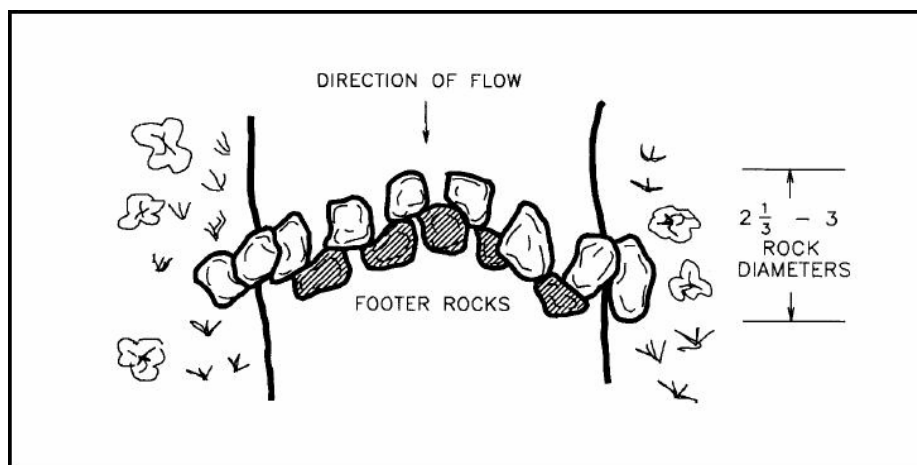
Figure 8. Vortex boulder weir plan view (CA DFG, 1998).

The V-shape of these structures gave them strength. Forces acting on the upstream rock at the center of the weir were transferred through the adjacent rocks and ultimately into the banks. We opted not to include spaces between the rocks to add to the contiguous nature of the structures. Additionally, the nature of a gradation of rock riprap helped to fill in those gaps and more successfully transfer those forces.

The V-shape of the weirs required less hardscape (rock riprap) than other alternatives, used only natural materials, and focused high flow energies into the center of the stream. When constructed, the alignment could be carefully placed to direct all flows to the preferred location and train the stream thalweg into a more favorable path. This reduced the impact of high energy flows on the banks, giving the bioengineered measures a better chance at success.

Flow concentration created a scour zone downstream of the weir at the center of the V which became the jump pool required by the Salmonid Manual. Each weir would also be passable during a wide range of flows.

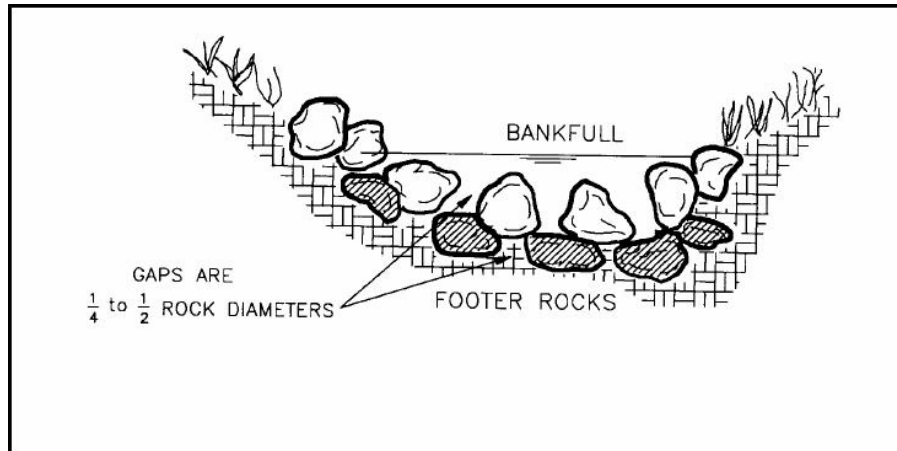
Figure 9. Vortex boulder weir cross-section (CA DFG, 1998).

The change in grade between the creek centerline and the daylight point of the weirs on the banks allowed a large range of flow volumes, including smaller flows, to be concentrated into the center of the channel. The weirs had to be designed and installed so that the jump height didn't exceed approximately one-half foot, the maximum allowable for juvenile passage. Given that our work was focused on just over 100 feet of the channel bottom, the weirs were spaced every 50 feet and differed in elevation by about 6 inches. The weirs were designed to contain a 2 to 5-year flow and the toe riprap was constructed to the 2-year storm elevation.

The draft version of NRCS' recently released Stream Restoration Design Handbook (USDA NRCS, 2007) was consulted for rock stream barb design to size the vortex weirs because they act as two stream barbs meeting at the center of the channel. The resulting design rock gradation was a  $D_{100}$  (maximum rock size, 100% of the rocks are that diameter and smaller) of 36 to 44 inches though a  $D_{100}$  of 48 to 54 inches was installed. All weir rock and rock riprap had to conform to the Rock Riprap (907) specification which requires rock to be angular and dense (specific gravity of 2.65 or greater) (USDA NRCS, 2007). Much of the strength of a rock weir structure lies in proper rock gradation. Large rocks take large forces but the smaller rocks wedged between them help to lock the structure in place, transfer forces, and prevent piping.

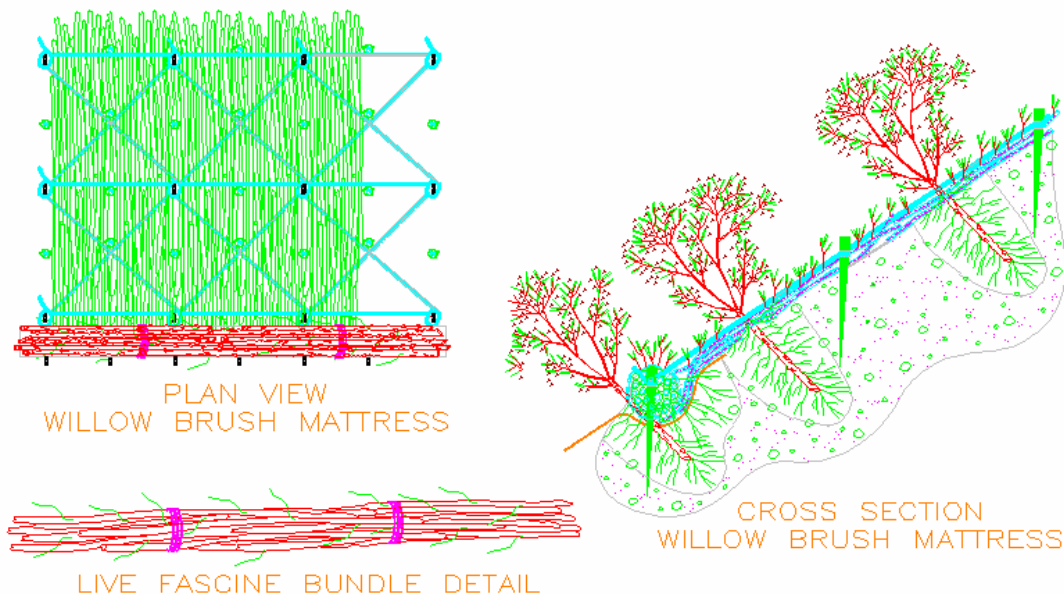
Figure 10. Willow brush mattress construction. Note that willow posts will not be leafed out nor rooting at the time of construction.

Brush mattress installations use four components: willow posts, a mat of willow branches, jute rope, and a willow fascine. Willow posts of 3-4" diameter are augered into the bank in a grid. They must be installed with the cut end down for proper root establishment. Between those posts a mat of ½ to 1 ½ inch diameter willow branches are laid along the banks. A natural rope, such as jute, is then used to secure the branches to the bank by cross-hatching the grid both diagonally and horizontally using the willow posts. Finally, fascines, 12 inch bundles of branches made of the same branches used for the brush mattress, are laid horizontally across the bottom ends of the brush mattress to press them into the earthfill. Some degree of growth is expected from each of the willow treatments. To retain some flow capacity after the willows will have bushed out in the future, the toe riprap was carried up the banks to the 2 to 5 year flow depth.

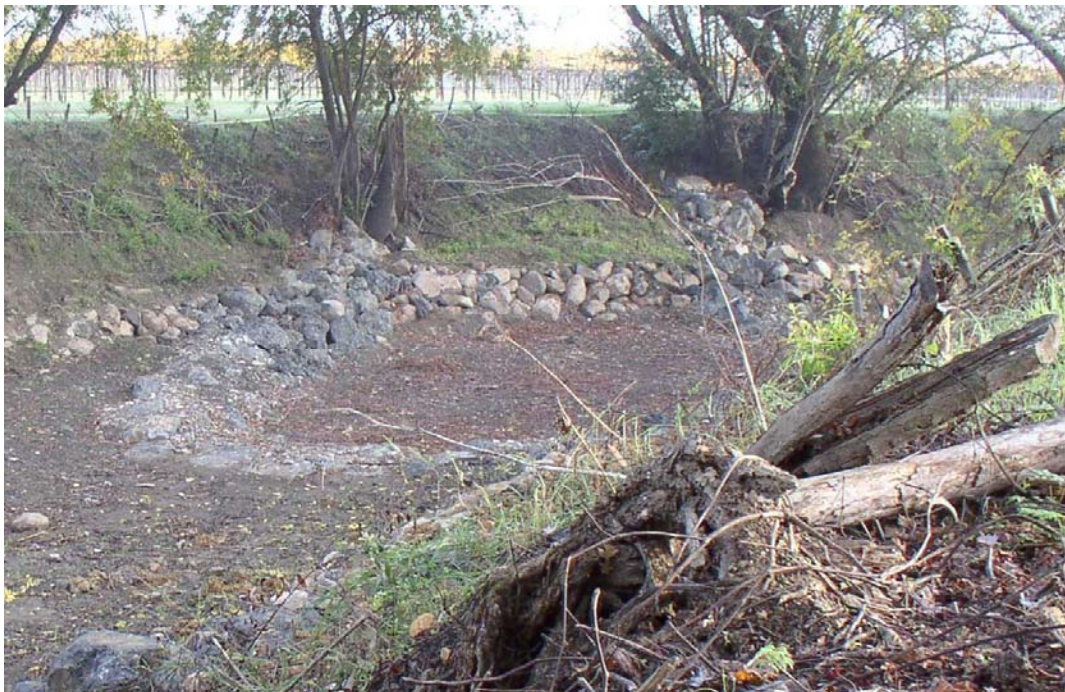
Figure 11. November 15, 2007 after construction. Note the two V-shaped weirs daylighting into existing trees.

During field staking, we opted to daylight the weirs into existing trees on the banks, which prevents flanking during high flows and can help take the forces transferred from the center key rock into the banks and the trees. To prevent the weirs from being compromised, they were keyed into the banks by about five feet so that the plunge pool wouldn't undercut and launch or dislodge the foundation boulders. Additionally, it was crucial to be sure that there were enough small rocks in the gradation to fill in the gaps between the larger rocks. This prevents piping and, in the end, the structure from being compromised.

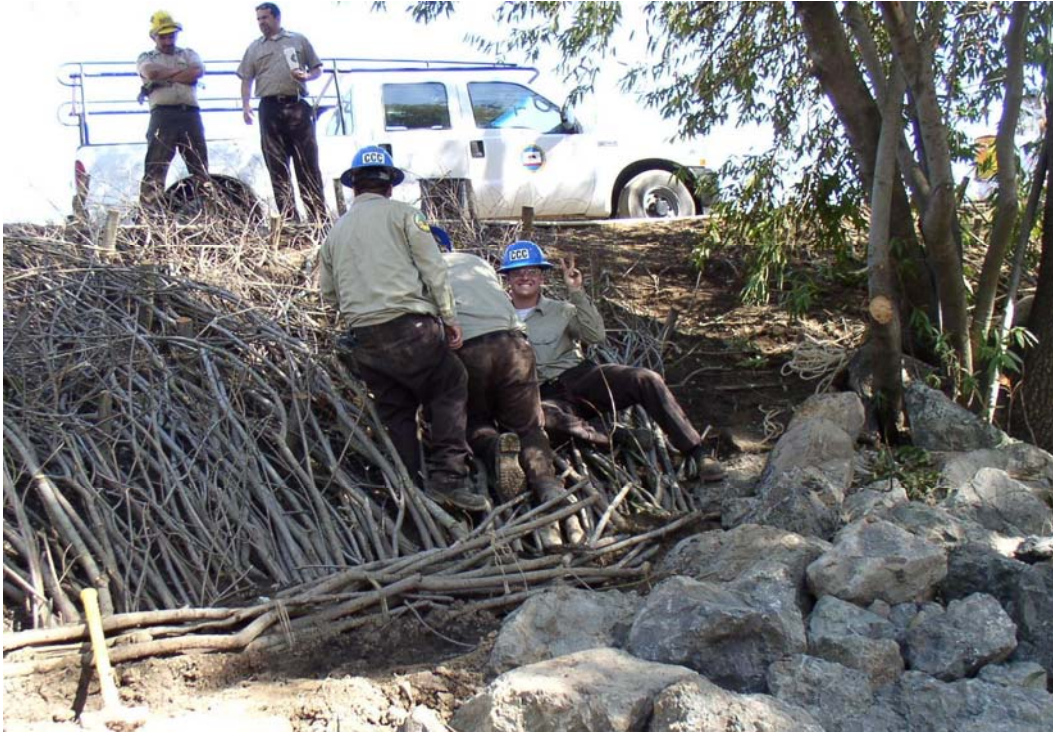
Figure 12. September 24, 2007 during construction. Note the fascine lying horizontally across the bottoms of the willow brush. The brush had to be compressed tightly while being tied down to the posts.

The first step of installing the brush mattresses was to auger holes into which the posts would be driven. Augering is necessary for willow post installation. If the posts are installed into an excavated trench, they will likely be eroded out since a trench is an easy path for water to take. Once the grid of posts were installed, willow branches were laid down and compressed. We could have used finer branches but since the supply was limited, we used what was available of the allowable species, Red willow (*Salix laevigata*) and Arroyo willow (*Salix lasiolepis*) (Blake, 2007). Locally available Sandbar willow (*Salix interior*) was not used because it tends to migrate into the center of the stream where it creates the sandbars for which it is named.

After the installation of the fascines, the last step was to “salt” soil over the brush mattress. The scattered earth helped to fill in the spaces between the brush with soil to aid in brush growth.

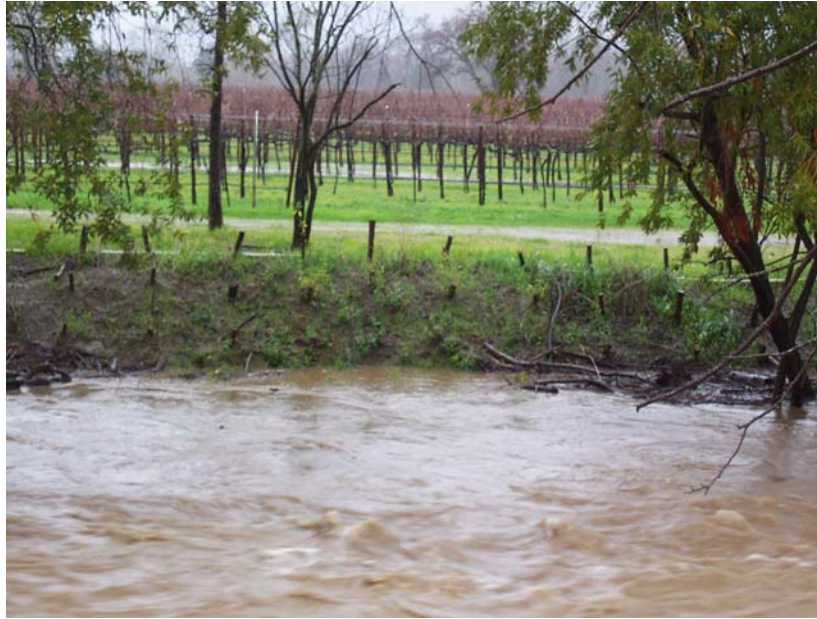
Figure 13. January 4, 2008 storm flow in the project reach, approximately 25-year storm. Flow is 3-4 feet from the top of bank.

Based on rain gauge data available on the Napa Valley Regional Rainfall and Stream Monitoring System (Napa Onerain), the rainfall depth on January 4<sup>th</sup>, 2008 corresponded with that of a 25-year, 24-hour storm in the Dry Creek watershed. The runoff and stream flows observed that day matched that predicted by the HEC-RAS<sup>TM</sup> model during the same 25-year storm flow. Water flowed about 3 to 4 feet from the top of bank during the peak of the storm runoff.

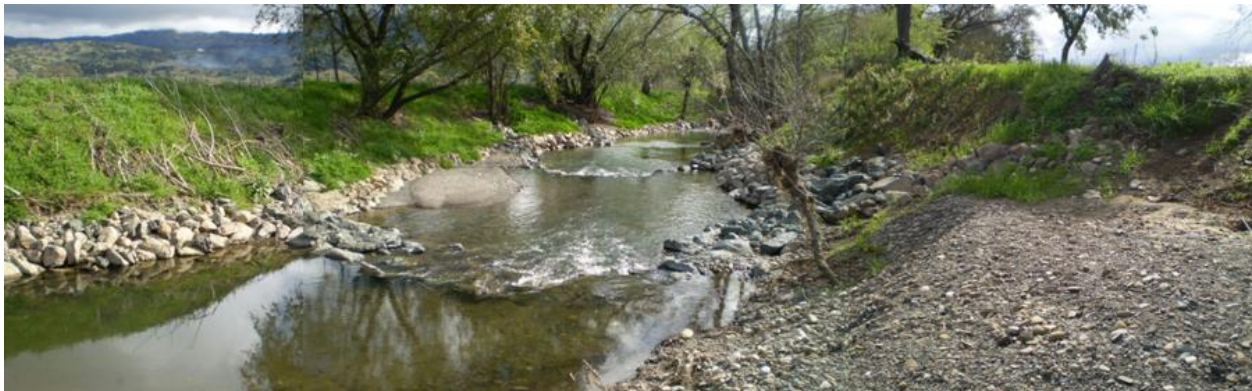
Figure 14. March 13, 2008, looking downstream.

Monitoring after that storm identified a small amount of damage to the project including a small amount of displaced brush from the south side brush mattress and some settling of the toe riprap on the upstream end of the north side rock toe. Neither of these are seen as detrimental but rather as lessons learned. The riprap toe was actually extended further upstream near the end of construction because there was rock left over. Though the left over rock was slightly smaller than optimal, we expected it to have adhered. It settled somewhat but the settling was minor.
